Monthly Oversight Report 29
ACS NPL Site
Griffith, Indiana
May 3, 2003 - May 30, 2003

Subject: Monthly Oversight Summary Report
No. 29 for May 2003

Monthly Oversight Summary Report No. 29
ACS Superfund Site WA57, 46526.238

Reporting Period: Month of May (May 2, 2003 - May 30, 2003)

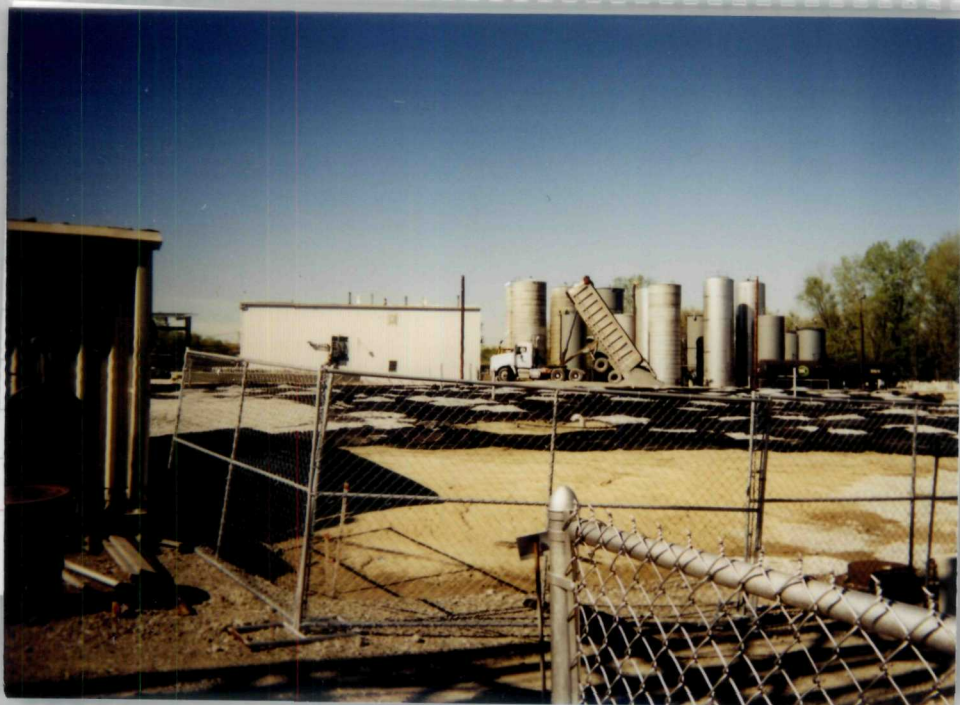
Site: American Chemical Services, Inc.
 Proj. # 46526
 Roll: 39 Photo #26
 Date: 05-01-03 Time: 09:25
 Photographer: Larry Campbell
 Description: Photo facing south-southwest showing truck dumping gravel to the west of the ONCA SBPA ISVE system blower shed concrete slab.

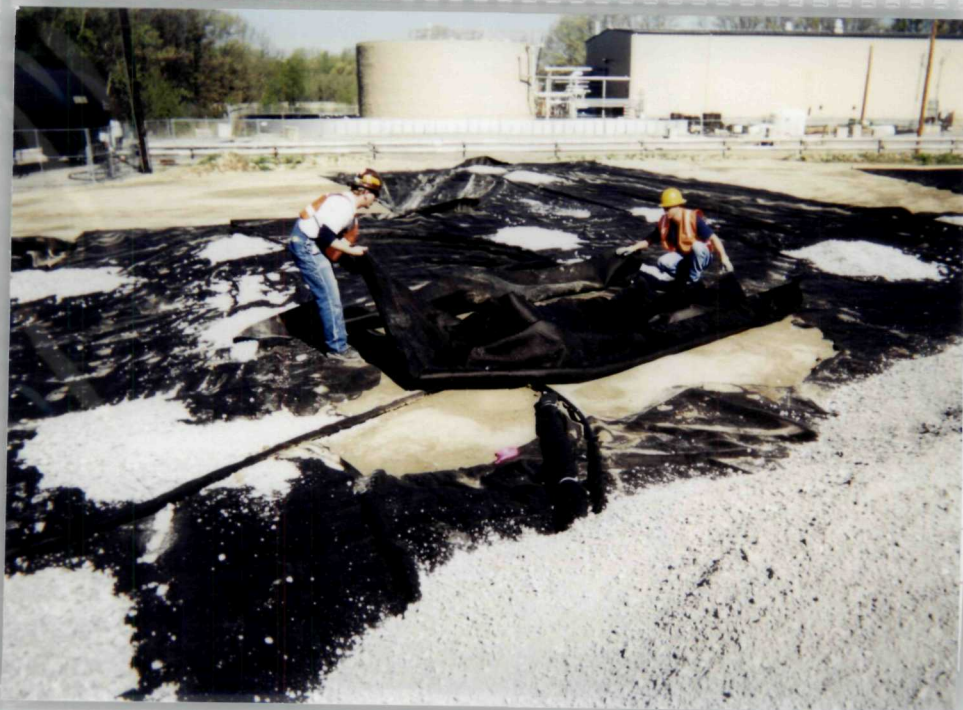
Site: American Chemical Services, Inc.
 Proj. # 46526
 Roll: 39 Photo #27
 Date: 05-06-03 Time: 09:35
 Photographer: Larry Campbell
 Description: Photo facing northwest showing MEI laying geotextile fabric around ONCA SBPA ISVE well SVE-58.

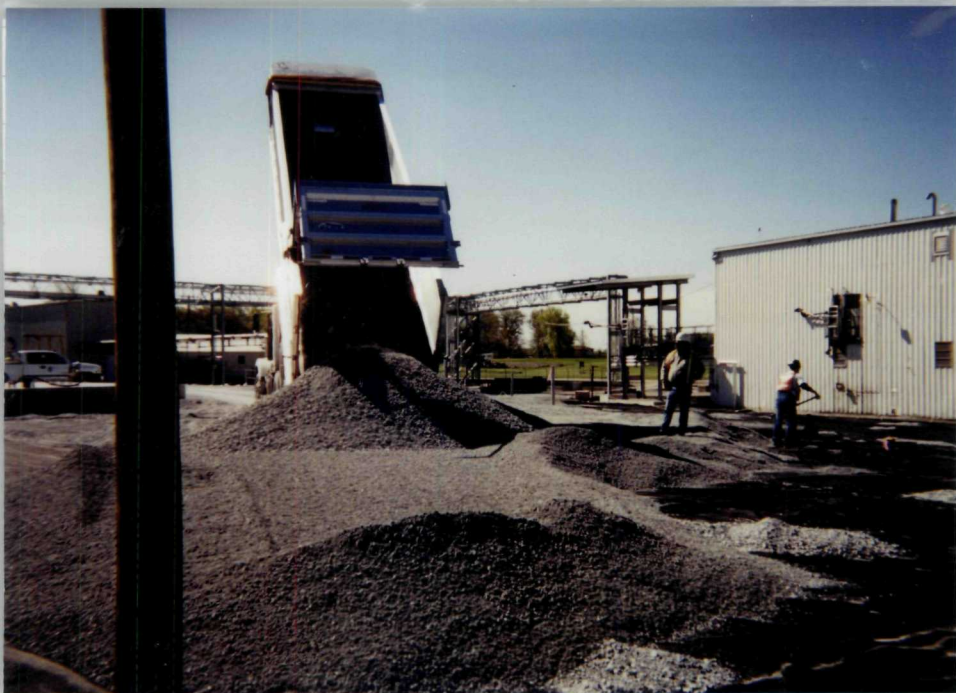
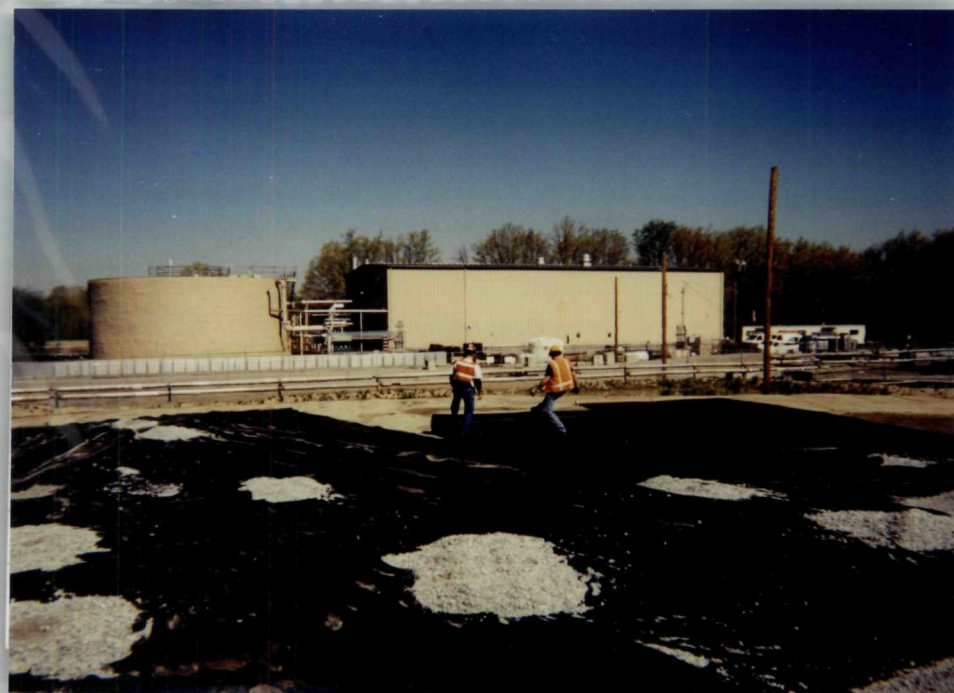
Description: Photo facing northwest showing MEI placing geotextile fabric on the ONCA SBPA interim clay cover.

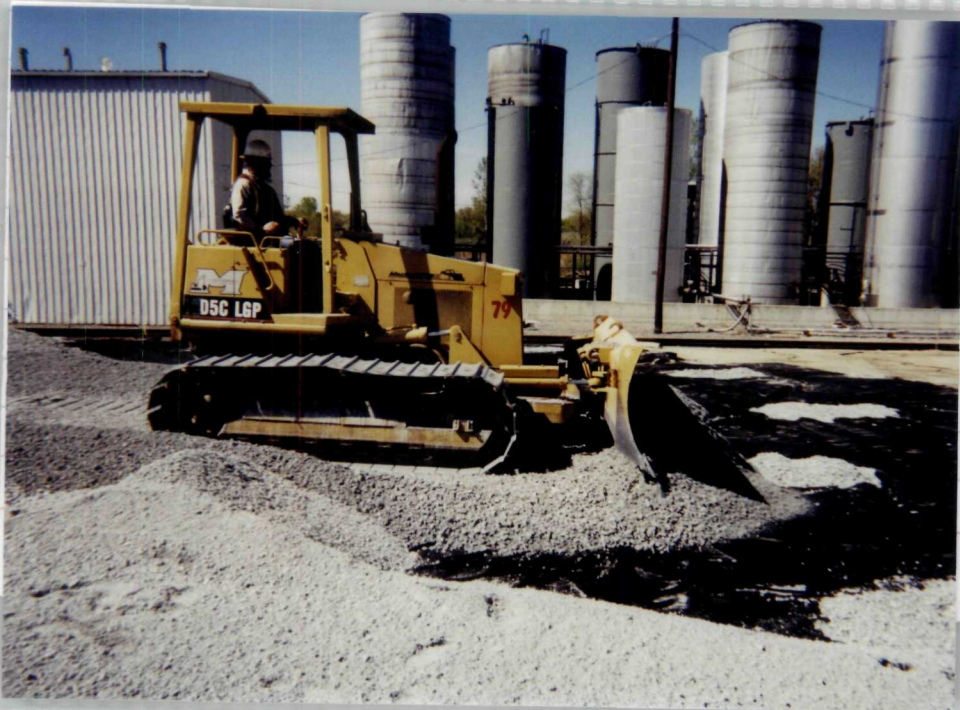
Site: American Chemical Services, Inc.
 Proj. #: 46526
 Roll: 40 Photo #3
 Date: 05-06-03 Time: 10:05
 Photographer: Larry Campbell
 Description: Photo facing south showing D5 dozer spreading gravel near ONCA SBPA ISVE well SVE-58.

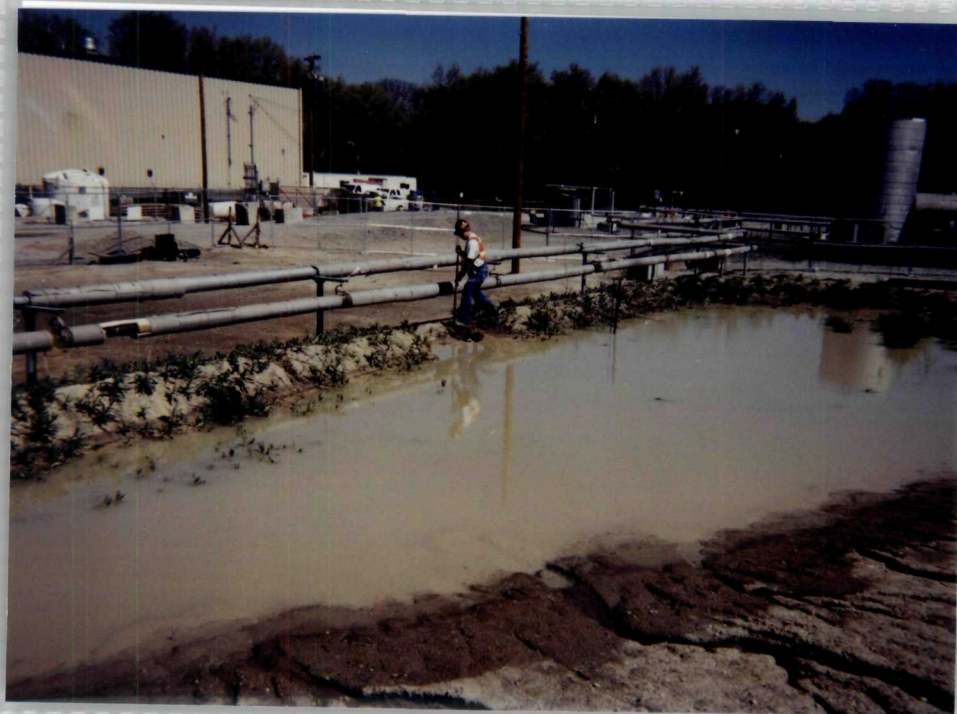
Site: American Chemical Services, Inc.
 Proj. #: 46526
 Roll: 40 Photo #4
 Date: 05-06-03 Time: 10:25
 Photographer: Larry Campbell
 Description: Photo facing northwest showing MEI digging a trench through the berm located on the west edge of the ONCA SBPA to drain ponded water.

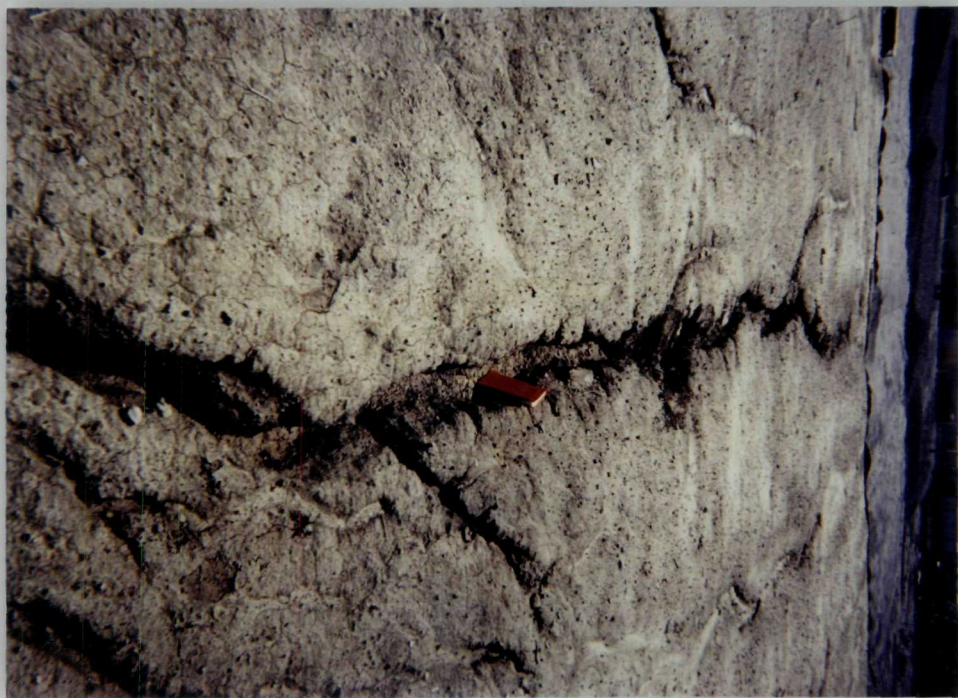
Site: American Chemical Services, Inc.
 Proj. #: 46526
 Roll: 40 Photo #5
 Date: 05-06-03 Time: 10:35
 Photographer: Larry Campbell
 Description: Photo facing east showing a 6-inch-deep erosion gully in the interim clay cover on the western edge of the ONCA SBPA. Note 7-1/2-inch tall field book.

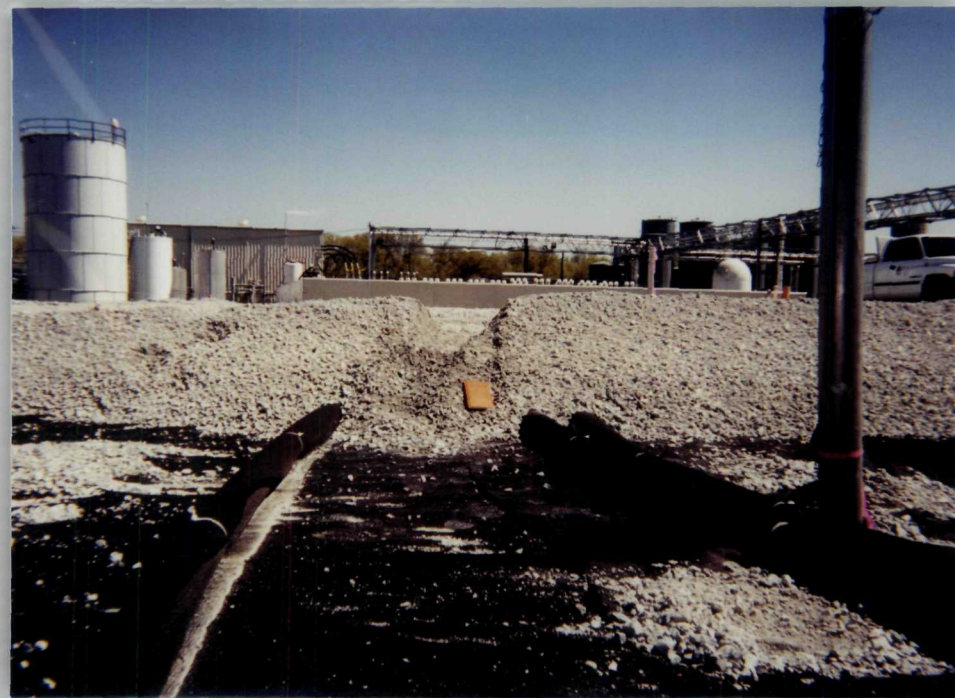
Site: American Chemical Services, Inc.
 Proj. #: 46526
 Roll: 40 Photo #6
 Date: 05-06-03 Time: 10:42
 Photographer: Larry Campbell
 Description: Photo facing north showing the additional gravel placed over the vapor yard piping near ONCA SBPA ISVE well SVE-71 to protect the piping.

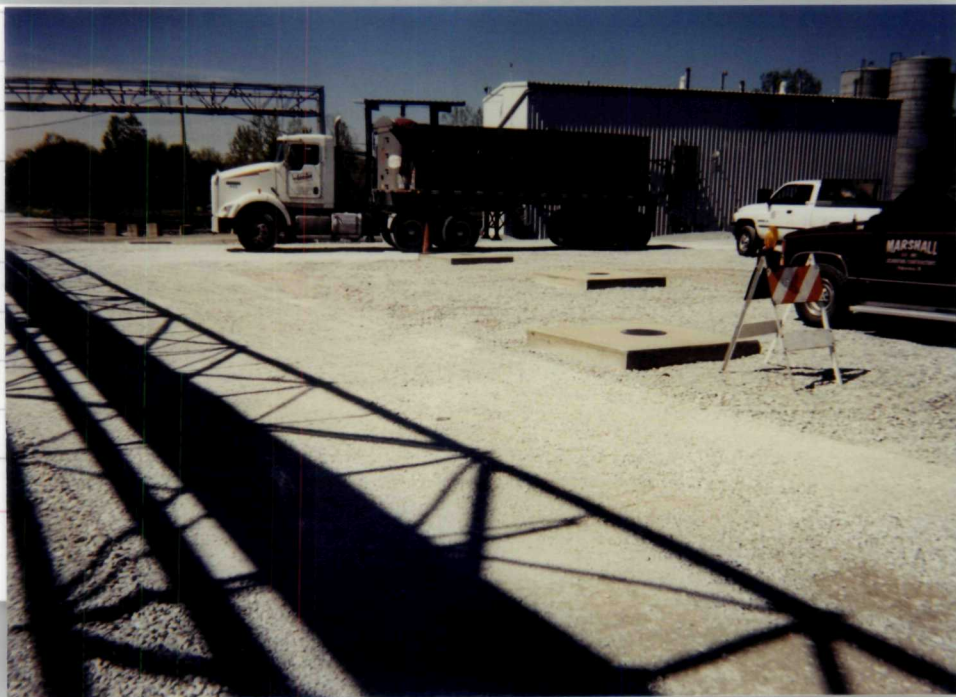
Site: American Chemical Services, Inc.
 Proj. #: 46526
 Roll: 40 Photo #7
 Date: 05-06-03 Time: 10:50
 Photographer: Larry Campbell
 Description: Photo facing south-southwest showing the concrete pad installed at the flushmount wells located in the access road.

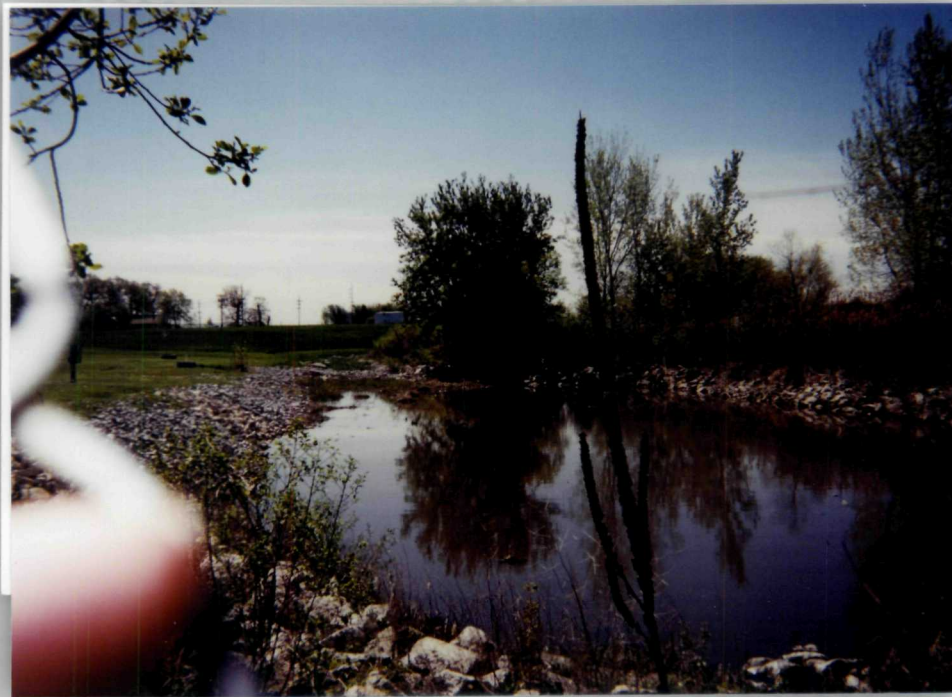
Site: American Chemical Services, Inc.
 Proj. #: 46526
 Roll: 40 Photo #8
 Date: 05-09-03 Time: 11:00
 Photographer: Larry Campbell
 Description: Photo facing southeast from the railroad tracks after heavy rains showing the OFCA retention pond.

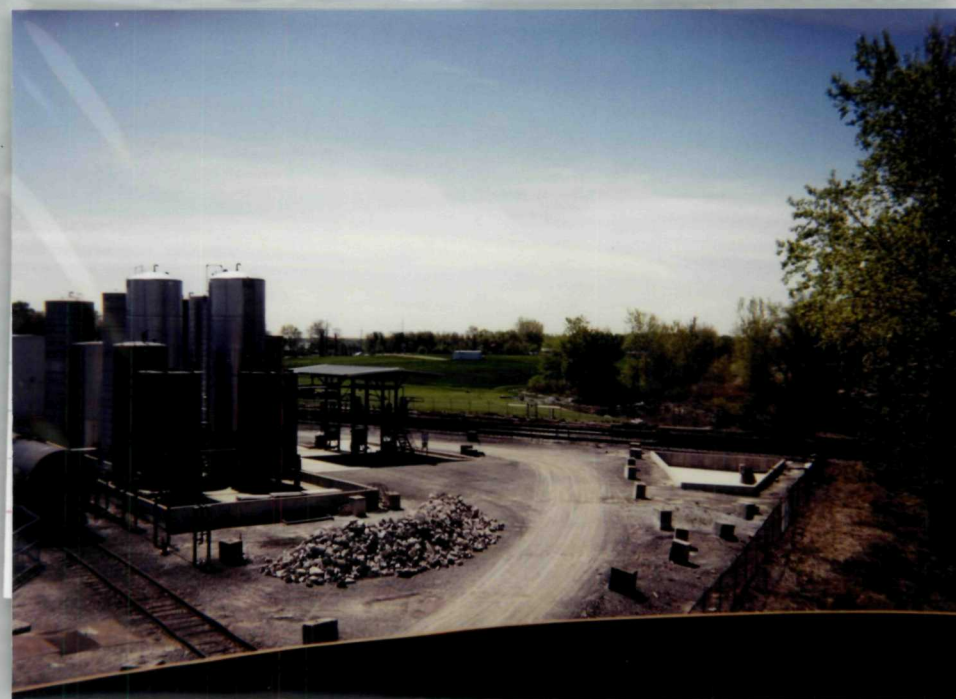
Roll: 40 Photo #9

Description: Photo facing east of the ONCA showing the geotextile and gravel placement. Note erosion gullies (see Photo 5) and drainage trench (see Photo 4).

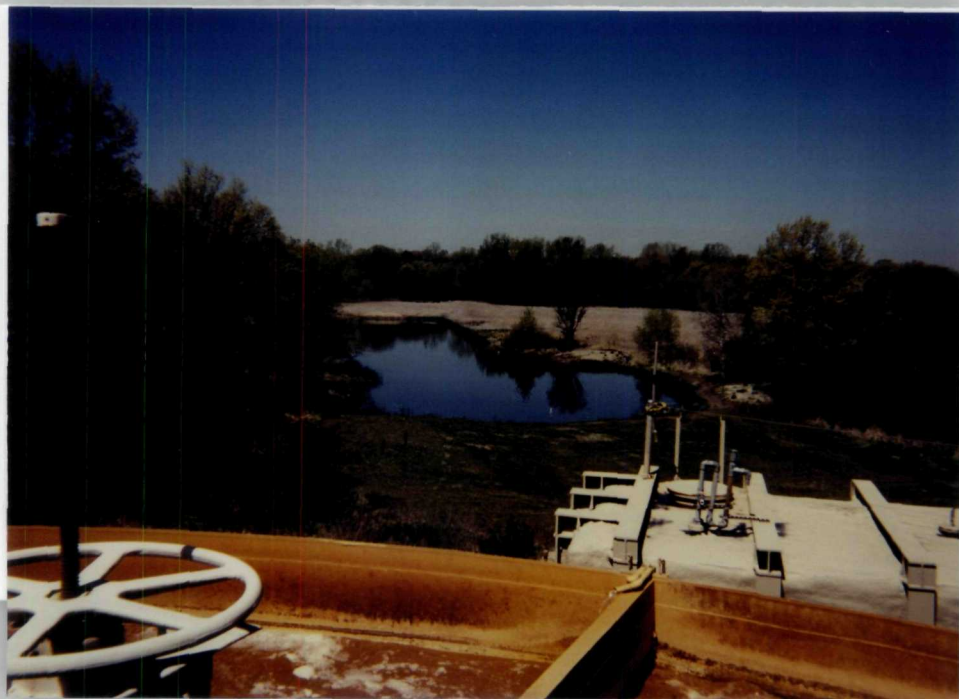
Roll: 40 Photo #10

Description: Photo facing southeast of the OFCA showing the retention basin and grass covered cover taken from the biotank.

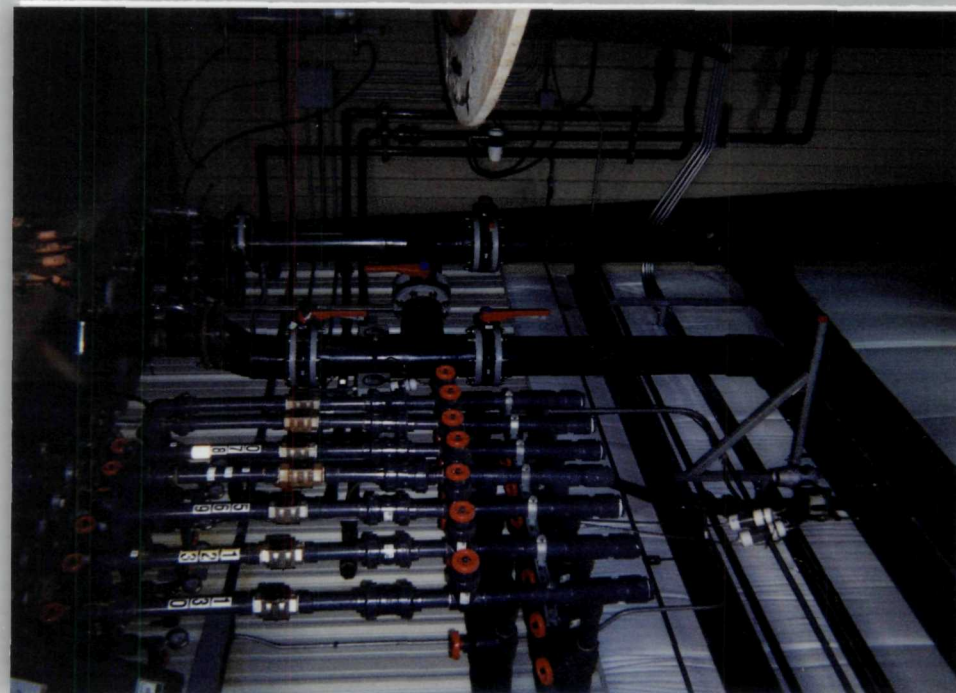
Description: Photo facing northwest at the ISVE air inlet in the GWTP showing the crossover piping to allow ONCA or OFCA ISVE vapors to be treated in either thermal oxidizer.

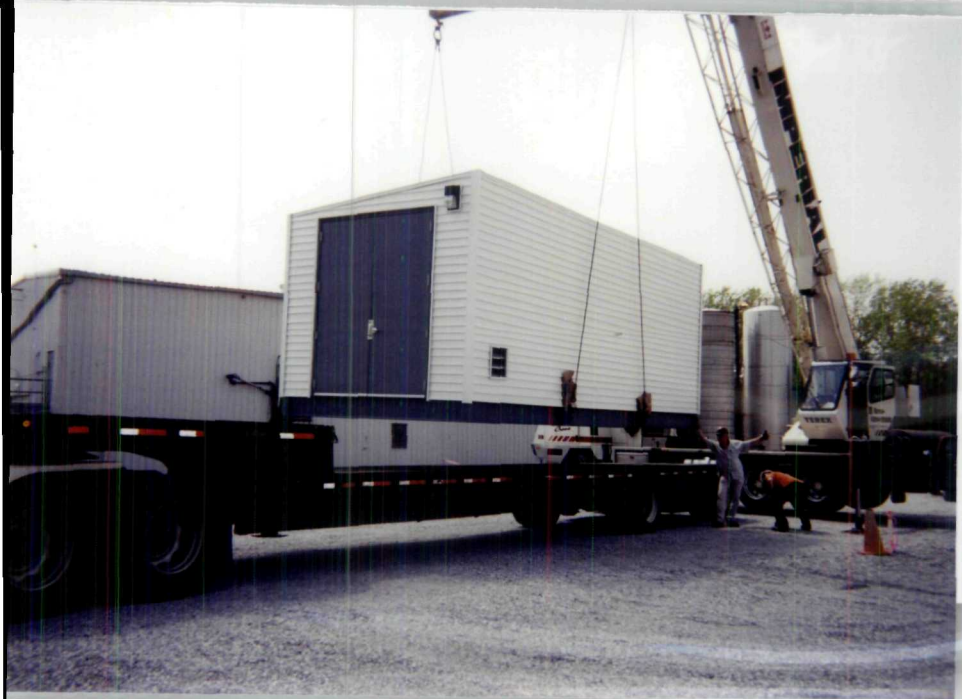
Site: American Chemical Services, Inc.
 Proj. #: 46526
 Roll: 40 Photo #21
 Date: 5-09-03 Time: 14:00
 Photographer: Larry Campbell
 Description: Photo facing southwest showing the
 ONCA SBPA ISVE system blower shed
 building #2 lifted off of the delivery truck.

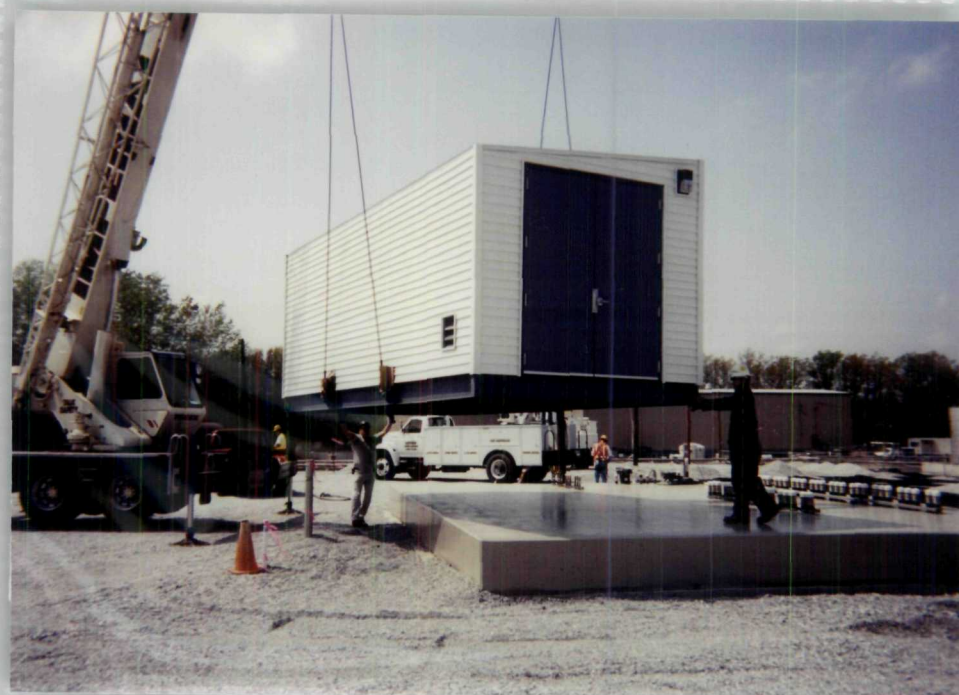
Site: American Chemical Services, Inc.
 Proj. #: 46526
 Roll: 40 Photo #22
 Date: 05-09-03 Time: 14:03
 Photographer: Larry Campbell
 Description: Photo facing northwest at the ONCA
 SBPA ISVE system blower shed building
 #2 being moved over the concrete slab
 foundation.

1400 Roll 40 Photo 20²¹ Looking NW
at Blower shed being moved
over foundation

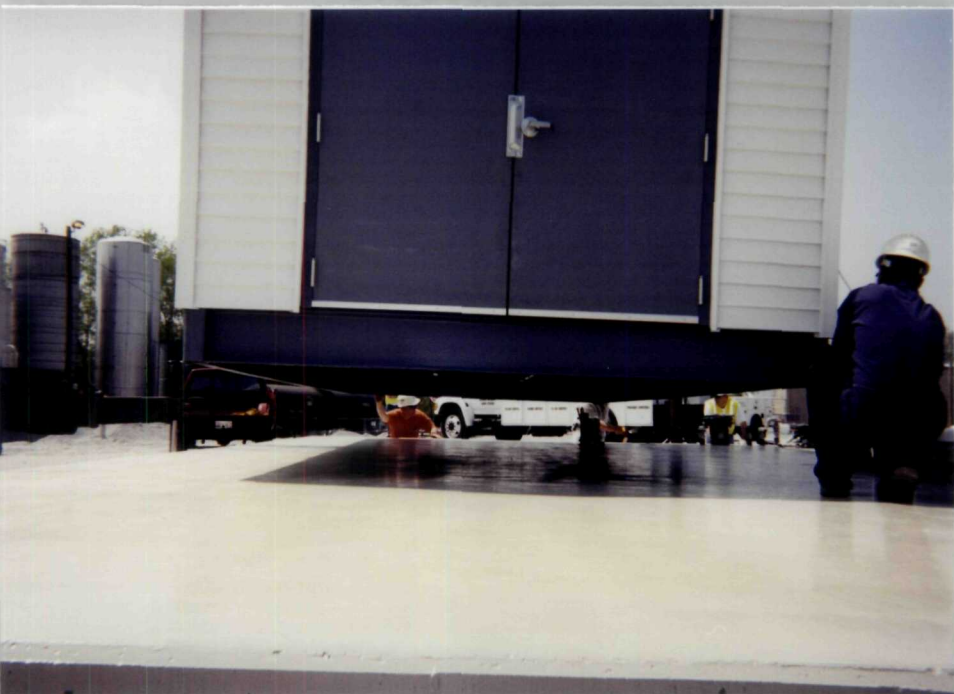
Site: American Chemical Services, Inc.
 Proj. #: 46526
 Roll: 40 Photo #23
 Date: 05-09-03 Time: 14:05
 Photographer: Larry Campbell
 Description: Photo facing west showing the ONCA
 SBPA ISVE system blower shed building
 #2 being aligned with the piping in the
 concrete slab foundation.

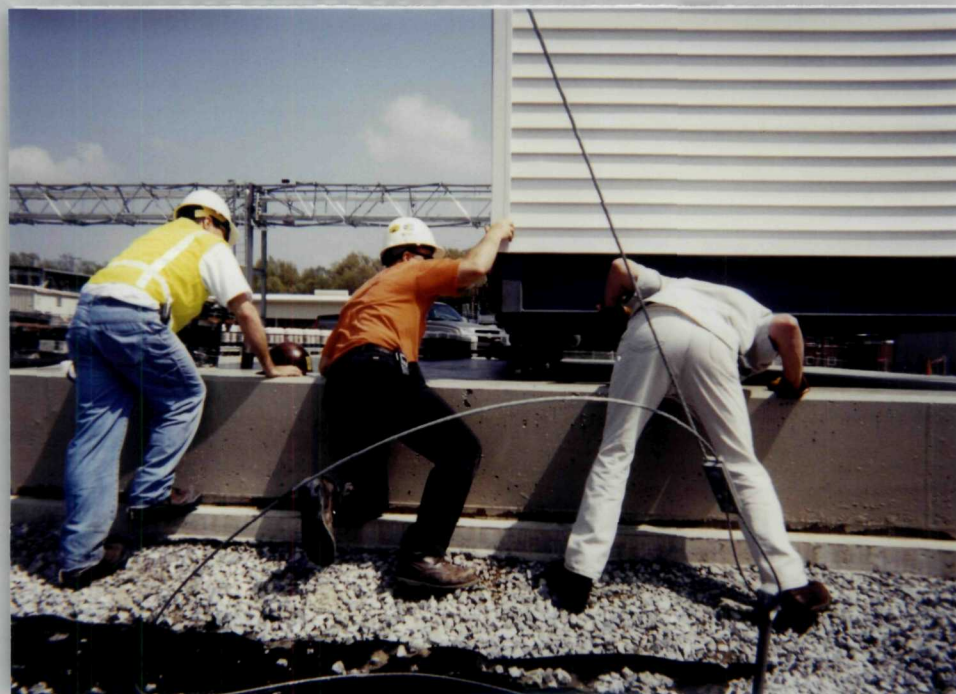
Site: American Chemical Services, Inc.
 Proj. #: 46526
 Roll: 40 Photo #24
 Date: 05-09-03 Time: 14:07
 Photographer: Larry Campbell
 Description: Photo facing east showing the ONCA
 SBPA ISVE system blower shed building
 #2 being lined up over the piping.

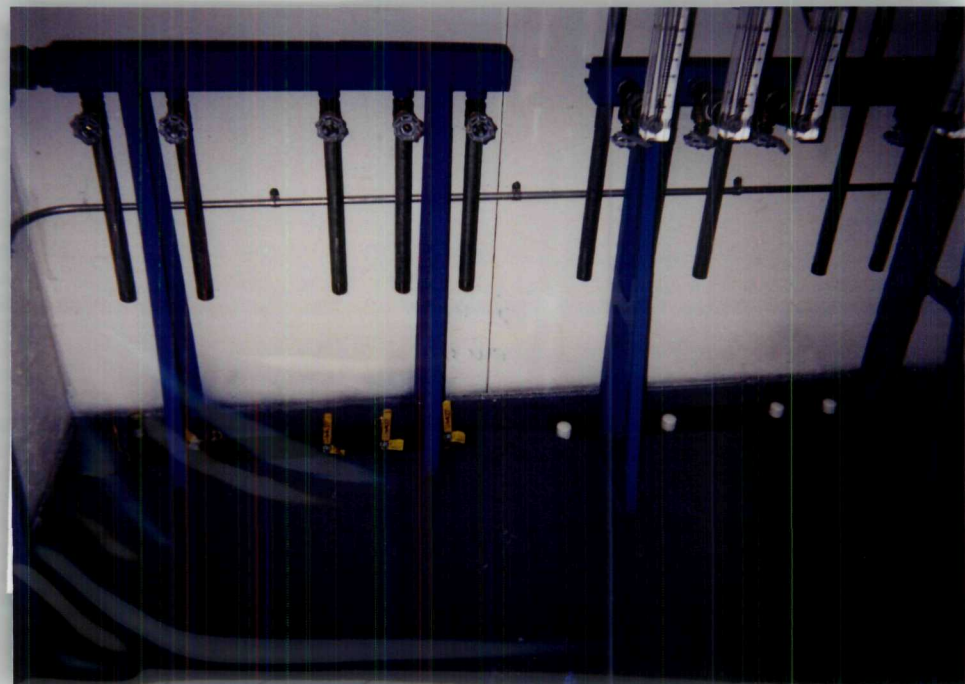
Description: Photo facing north inside the ONCA SBPA ISVE system blower shed building #2 showing the tight fit of the air sparge and DPE well water lines through the floor.

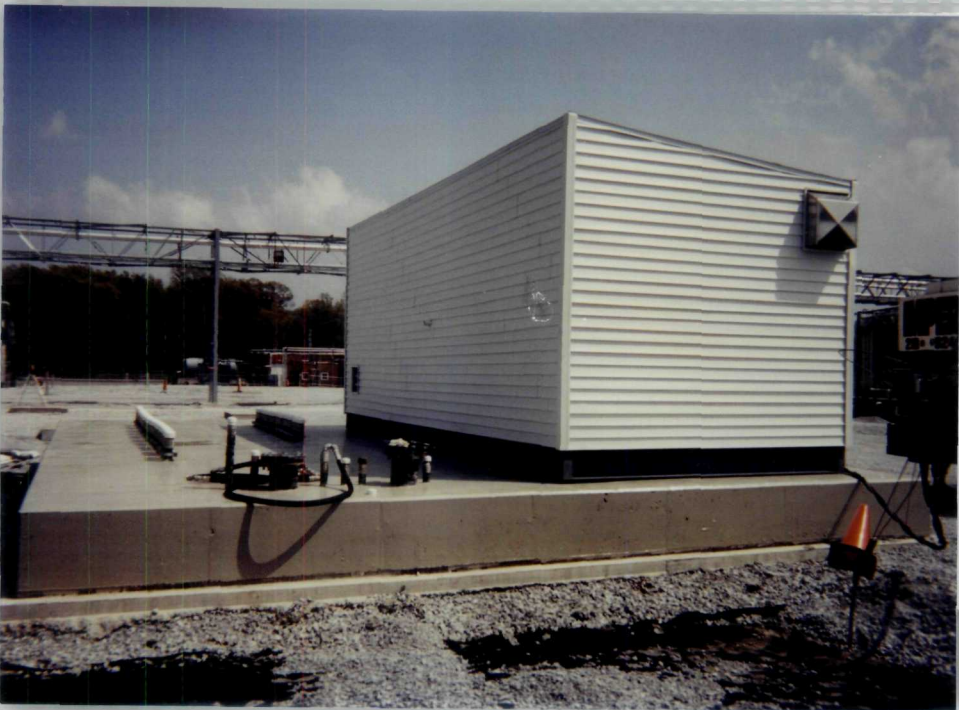
Site: American Chemical Services, Inc.
 Proj. # 46526
 Roll: 40 Photo #27
 Date: 05-09-03 Time: 14:35
 Photographer: Larry Campbell
 Description: Photo facing southeast showing the
 ONCA SBPA ISVE system blower shed
 building #2 setting on the pad.

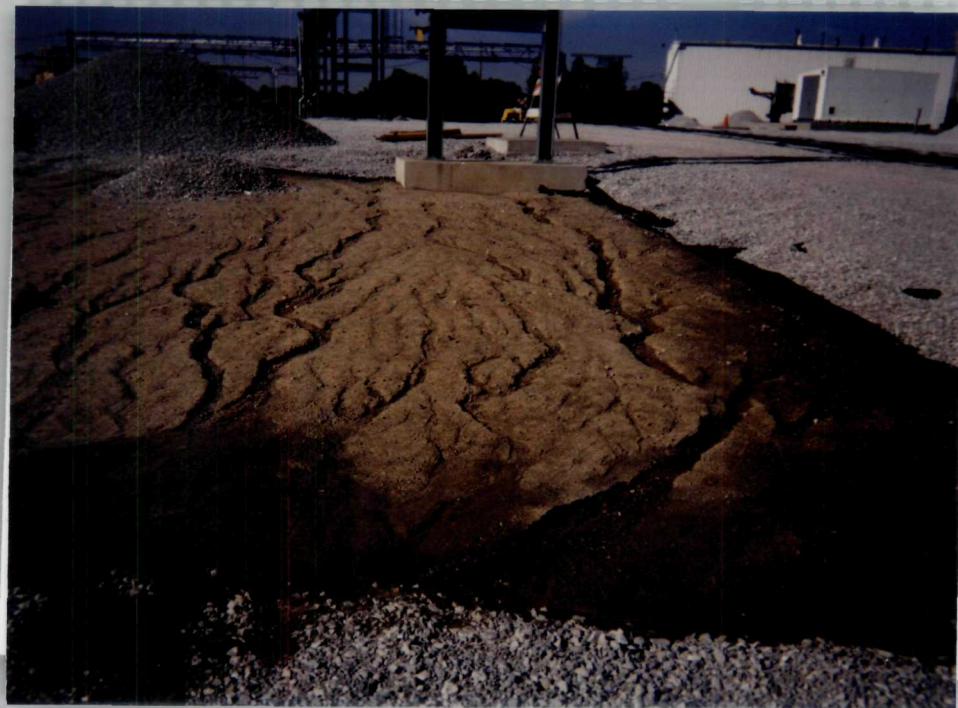
Site: American Chemical Services, Inc.
 Proj. #: 46526
 Roll: 41 Photo #1
 Date: 05-13-03 Time: 08:30
 Photographer: Leigh Peters
 Description: Photo facing south showing erosion in the
 northern portion of the ONCA SBPA
 interim clay cover, east of the ACS break
 building.

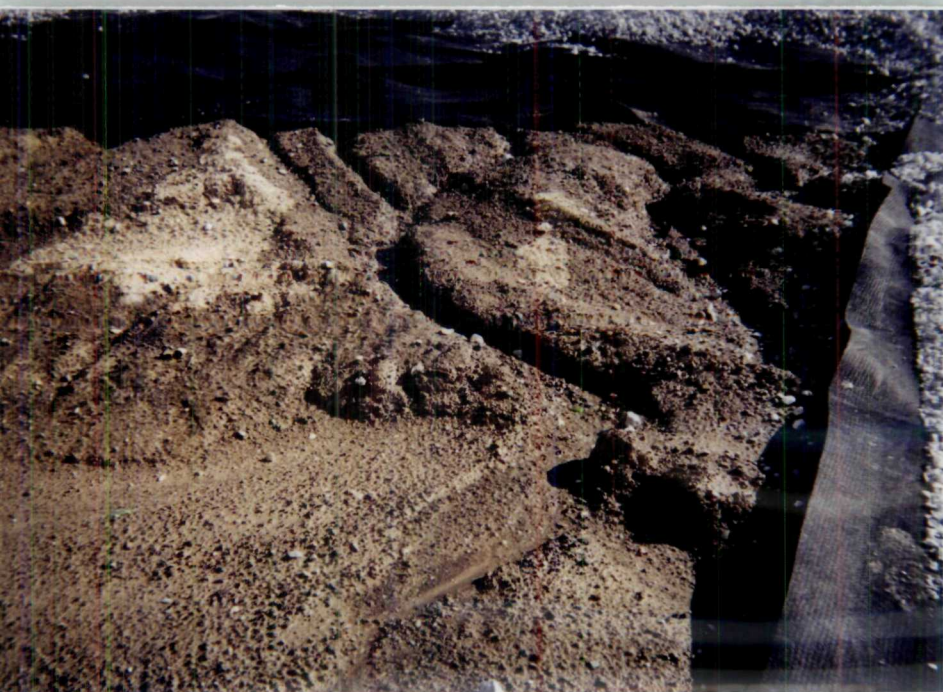
Site: American Chemical Services, Inc.
 Proj. #: 46526
 Roll: 41 Photo #2
 Date: 05-13-03 Time: 08:32
 Photographer: Leigh Peters
 Description: Photo facing north showing the fresh erosional trails in the south portion of the ONCA SBPA interim clay cover near the railroad tracks.

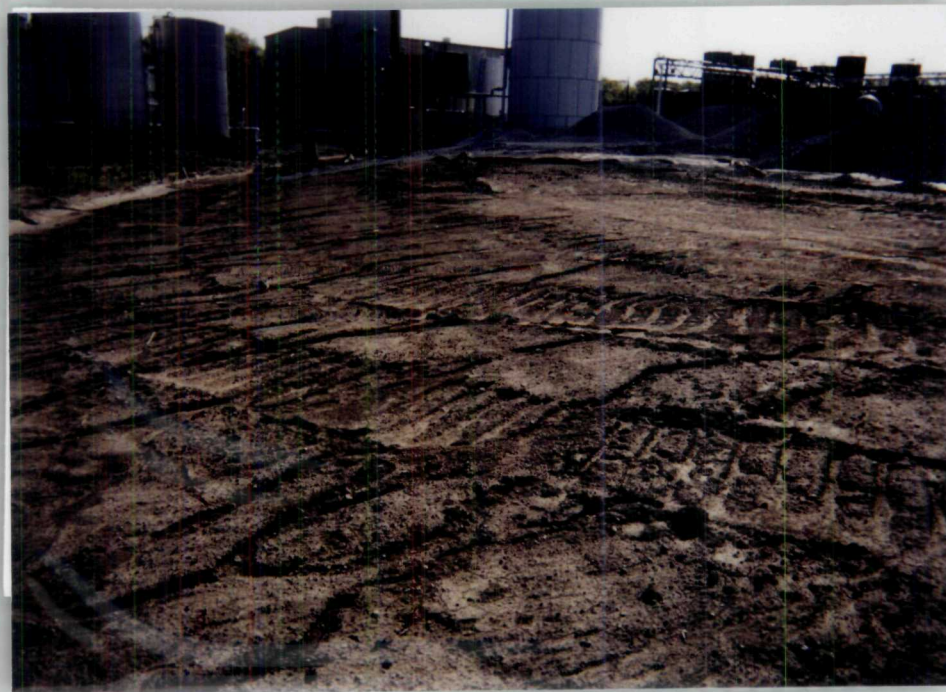
Site: American Chemical Services, Inc.
 Proj. #: 46526
 Roll: 41 Photo #3
 Date: 05-13-03 Time: 08:35
 Photographer: Leigh Peters
 Description: Photo facing northeast showing erosion rivulettes on the western portion of the ONCA SBPA interim clay cover that formed after heavy rains.

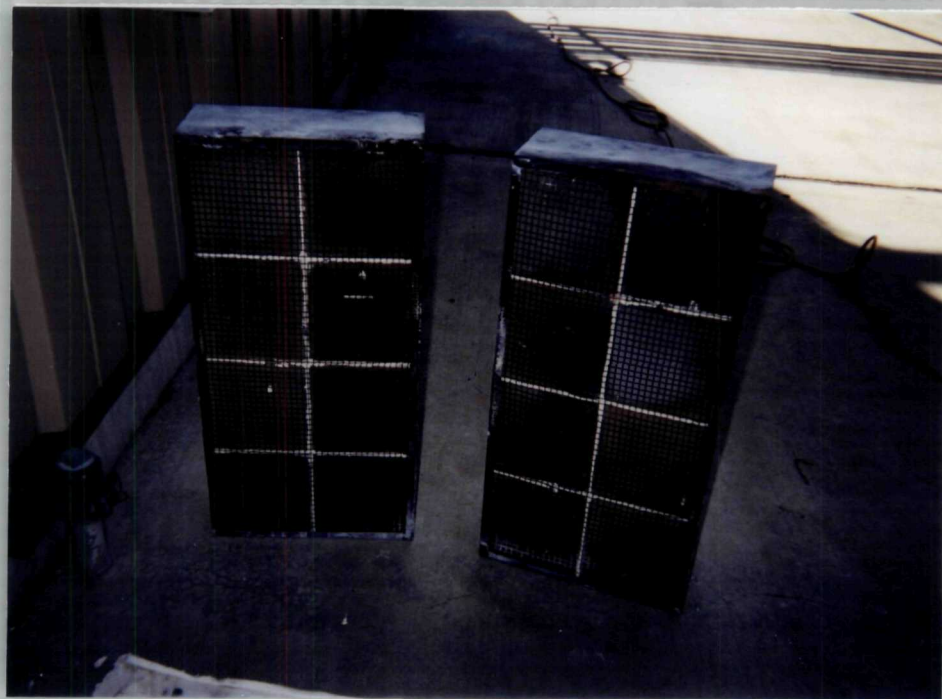
Description: Photo facing east showing the effluent air side of the catalyst from the catalytic oxidizer in the GWTP.

extraction trenches, dual phase extraction wells in the Still Bottoms Pond Area (SBPA), and the Perimeter Groundwater Collection System (PGCS). The GWTP was shut down on May 13th when a pressure differential alarm for the catalytic oxidizer unit sounded. The system was shut down for approximately 24 hours so that the catalyst could be removed, cleaned, and replaced. During this period the thermal oxidizer unit for the Off-Site area was also shut down due to a programming error. The error was located and the unit was brought back on line.

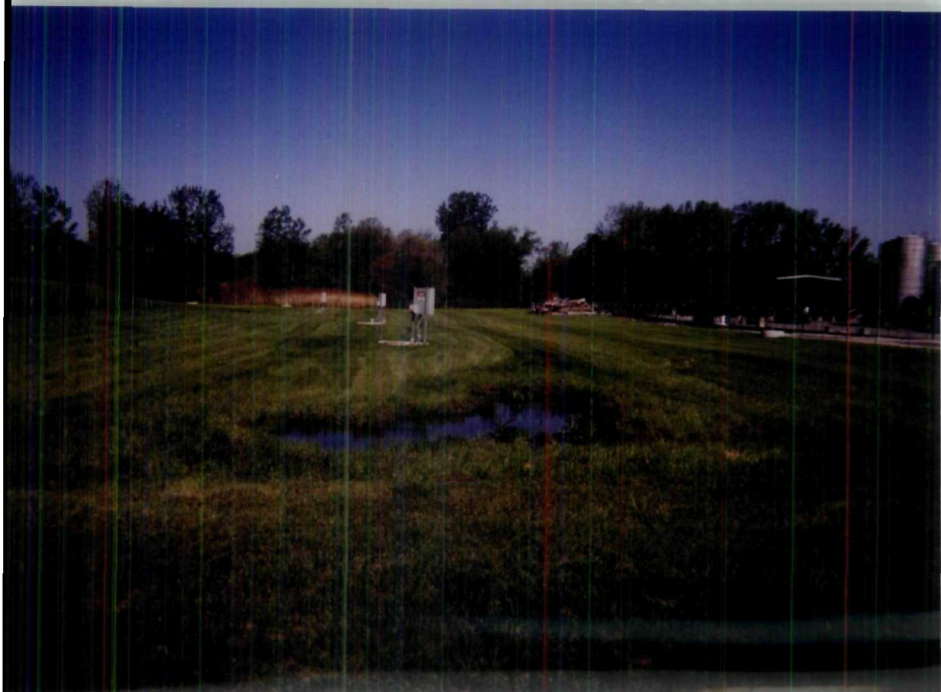
Site: American Chemical Services, Inc.
 Proj. #: 46526
 Roll: 41 Photo #6
 Date: 05-13-03 Time: 09:40
 Photographer: Leigh Peters
 Description: Photo facing west from EW-20C manhole
 showing the ponded water on the OFCA
 cover.

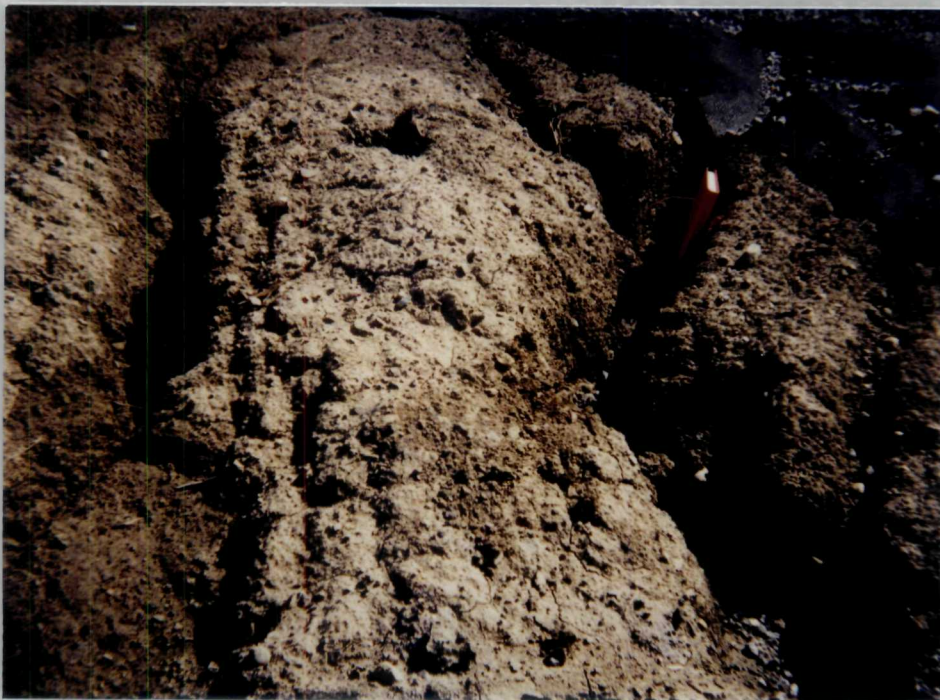
Site: American Chemical Services, Inc.
 Proj. #: 46526
 Roll: 41 Photo #7
 Date: 05-13-03 Time: 09:42
 Photographer: Leigh Peters
 Description: Photo facing west at the ground showing
 the erosion and exposed conduit for the
 fiber optic cable between the GWTP and
 the OFCA blower shed.

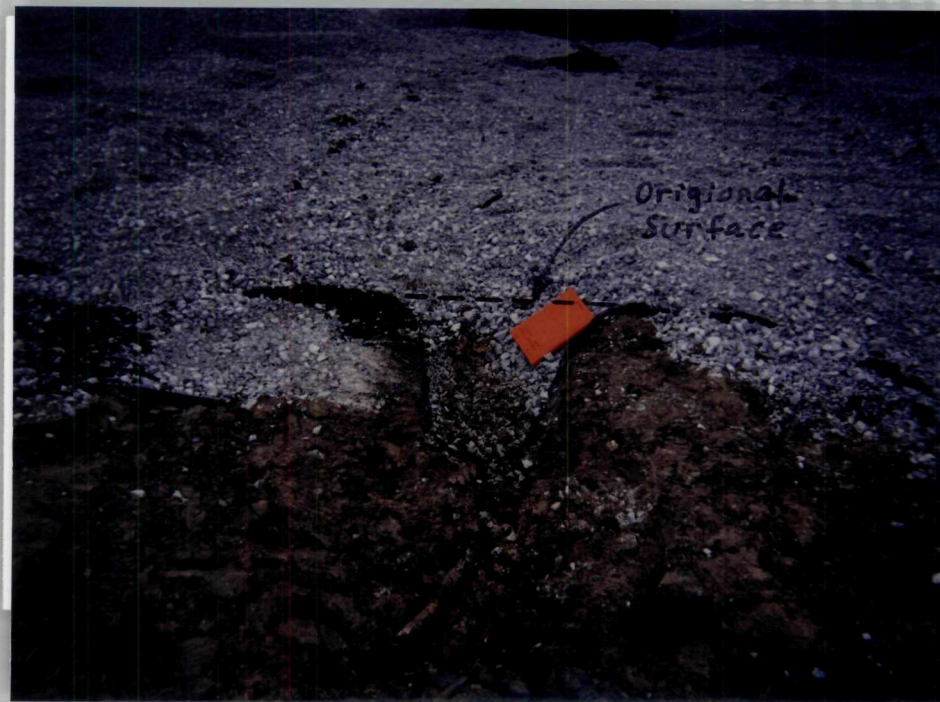
Description: Photo facing east at the west end of the ONCA showing the geotextile fabric placed in erosion gully and filled with gravel.

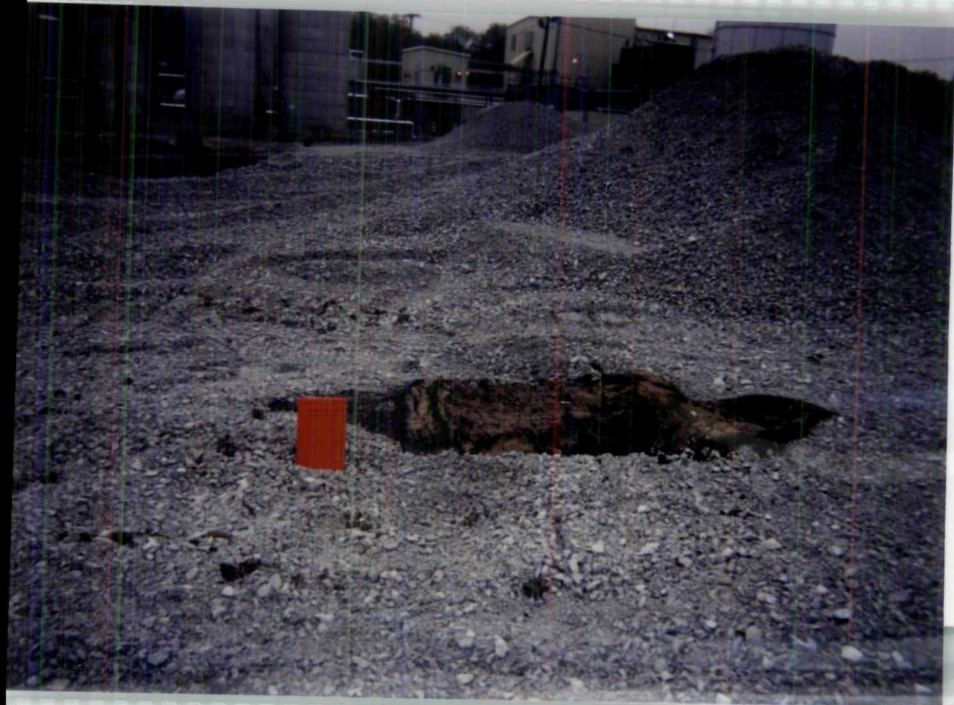
Description: Photo facing north showing torn geotextile fabric with soft clay protruding up through the geotextile fabric, 20 feet east of Photo 13.

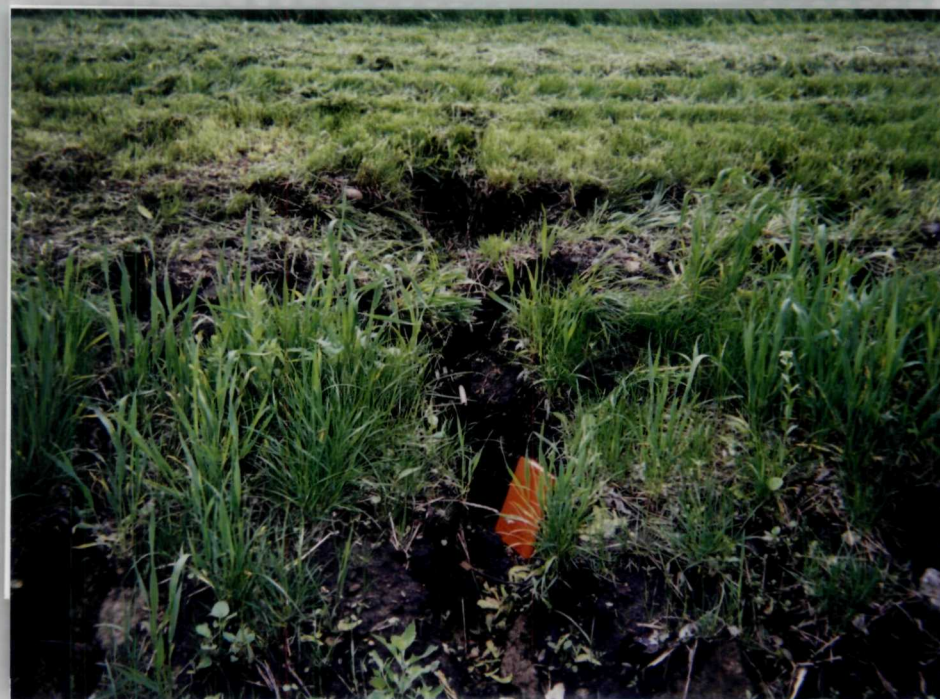
BVSPC observed erosional damage to the western portion of the OFCA engineered cover. MWH walked the OFCA engineered cover on May 29, 2003, and noted the areas where additional maintenance is needed. MWH reported that it will submit a formal plan to the Agencies to address the maintenance activities. BVSPC also inquired about the tree trunks and wood chips located on the OFCA engineered cover. MWH reported that it would discuss this issue with the Agencies.

Description: Photo facing east at erosion gully in the
west edge of the OFCA engineered cover
near piezometer P116.

Larry Campbell of Black & Veatch said that he noticed some erosion areas in the Off-Site cover. Todd Lewis, MWH, and Rob Adams, MWH, indicated that they would be at the site the week of May 26th and would inspect the erosion areas in order to determine a plan for repairing these damaged areas. This plan will be discussed with the Agencies prior to implementation. Mr. Campbell also asked about the future status of the tree stumps that remain on the non-engineered portion of the cover. Currently there are no plans to dispose of these stumps other than to let them degrade where they are. Peter Vagt, MWH, and Kevin Adler, U.S. EPA, indicated they would discuss the options for the stumps and will determine their final disposition.

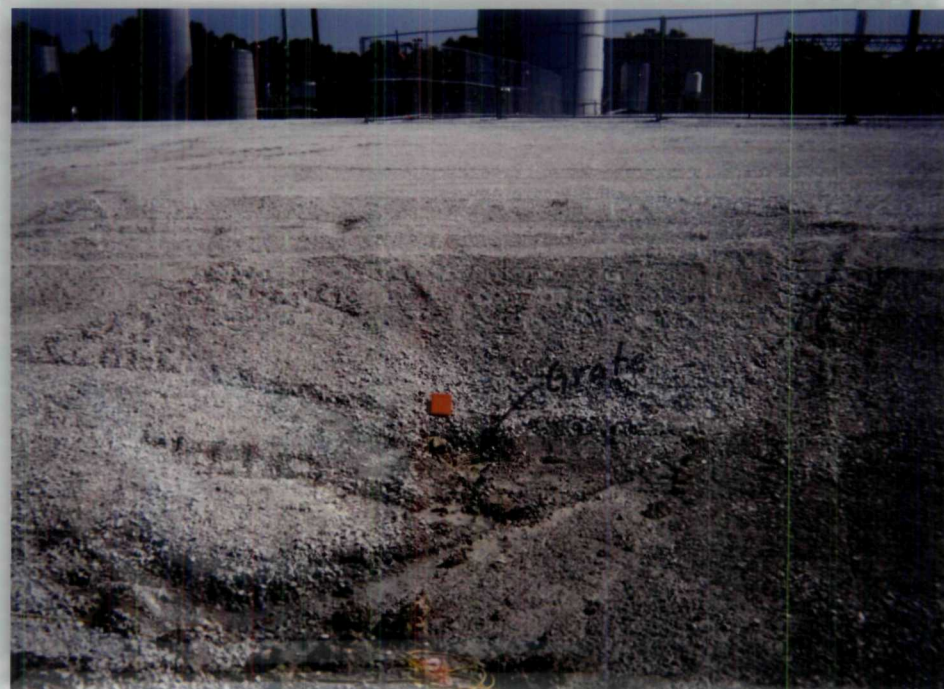
Site: American Chemical Services, Inc.
 Proj. #: 46526
 Roll: 41 Photo #22
 Date: 05-22-03 Time: 09:40
 Photographer: Larry Campbell
 Description: Photo facing west showing DPE well SVE-50 not completely backfilled and awaiting concrete pad installation on the east end of the ONCA SBPA gravel cover.

0940 Bell 41 Photo 21 Looking W
at E end of SRP at gravel
cover - showing DPE SVE well 50
not completely buckled -
awaiting placement of
concrete cap

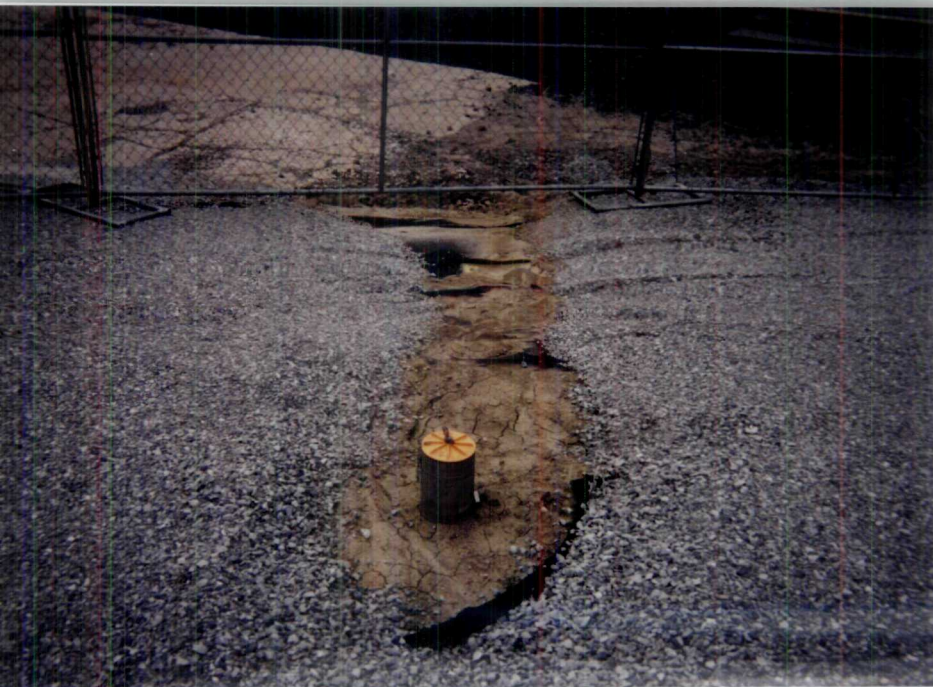
Roll: 41 Photo #24

Description: Photo facing east showing the western edge of the ONCA SBPA gravel cover.

0949 Bell 41 Photo 24 Looking E
at gravel cover on W side of
SRP

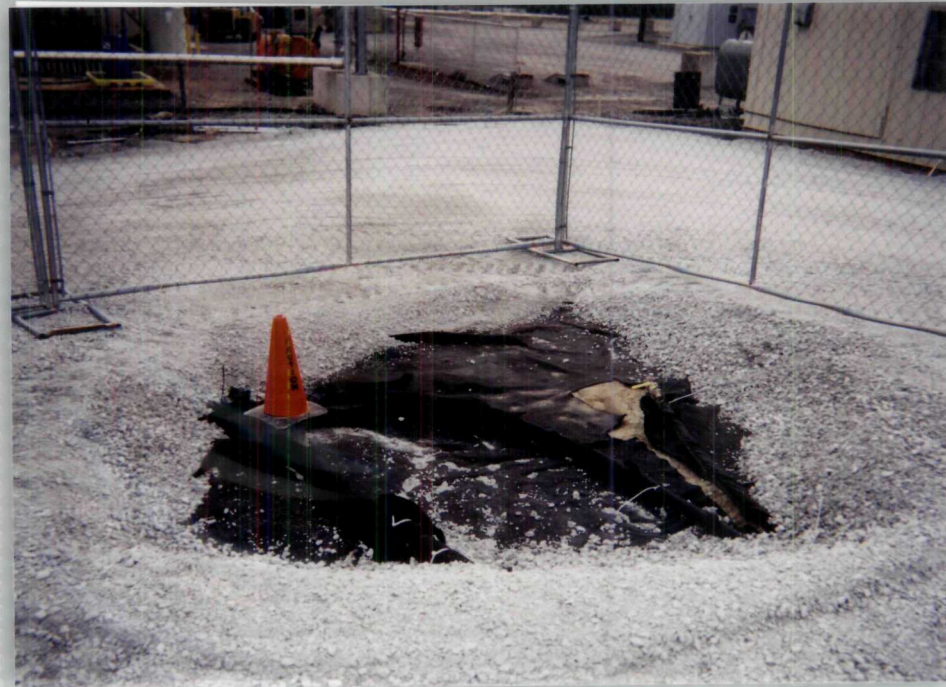
Site: American Chemical Services, Inc.
 Proj. # 46526
 Roll: 41 Photo #26
 Date: 05-28-03 Time: 14:35
 Photographer: Leigh Peters
 Description: Photo facing south showing DPE well SVE-86 and the exposed clay and geotextile that are awaiting backfill and concrete pad installation.
